Inspection Services Division

## MEMORANDUM

**Subject:** Construction Energy Inspections

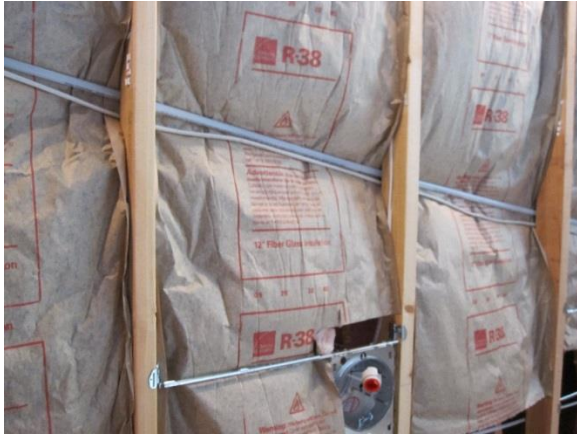
**Figure 1** - This faced fiberglass batt insulation was **incorrectly installed**; it should be cut to fit around wiring and obstructions so that it can completely fill the wall cavity without compressions and voids

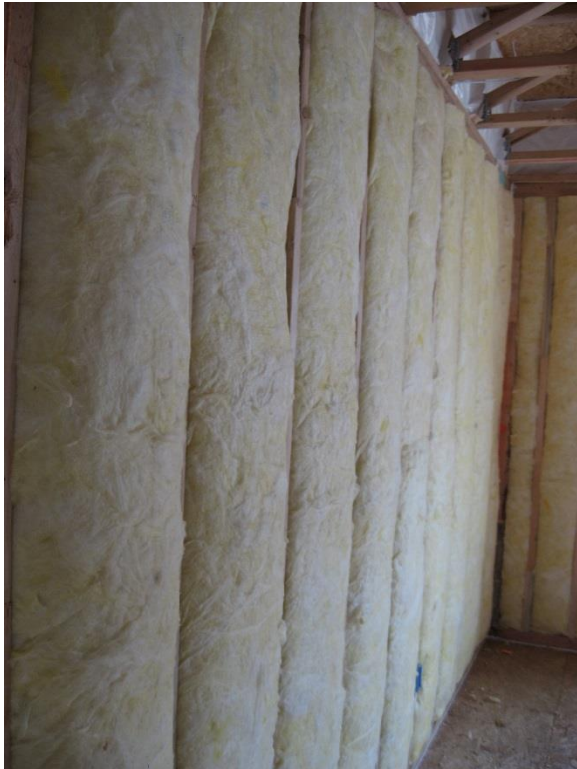
**Figure 2** - Unfaced fiberglass batt insulation is **correctly installed** to completely fill the wall cavities and is sliced to fit around wiring, piping, and other obstructions in the wall cavities without compressing the insulation.

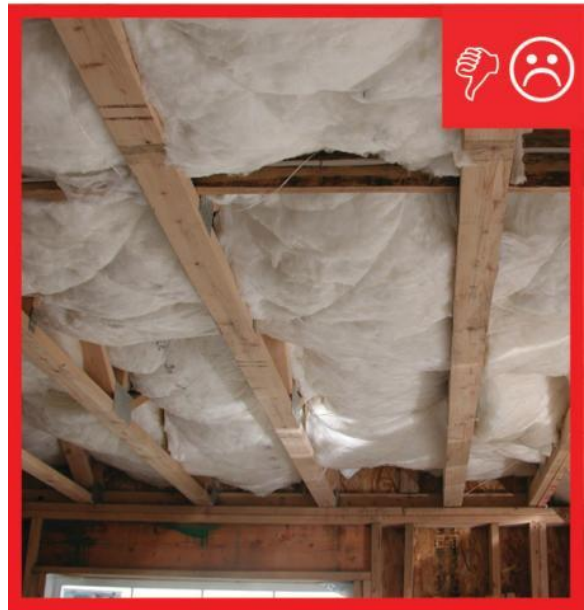
**Figure 3** – This unfaced fiberglass insulation has been **incorrectly installed** due to misalignment, compression, and gaps; it should be cut to fit so that it can completely fill the cavity without any compressions and voids.

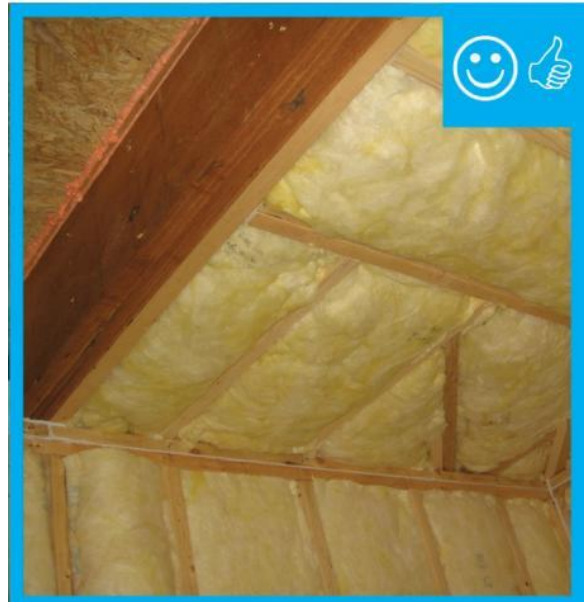
**Figure 4** – This unfaced fiberglass insulation has been **correctly installed** to completely fill the wall cavities and is sliced to fit to eliminate compression of the insulation or voids and gaps in the insulation.
